EXPERIMENTAL STUDIES OF TOWER STRUCTURES WITH HYSTERETIC DAMPERS

Keywords: Truss Tower, Seismic Retrofit, Buckling Restrained Brace, Connections

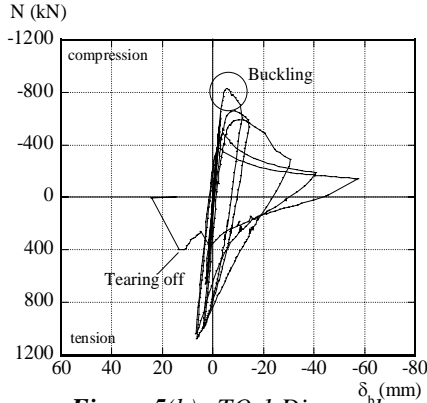
Figure 5(a). TO-1 Frame

Figure 5(b). TO-1 Diagonal

The test results are shown in Figure 5-8. In each figure, part (a) shows the load-displacement relationships of the truss structures, and part (b) shows the axial force-deformation relationships of the diagonal members. For TO-1, a story drift of up to 1/100 was followed by slipping of the connection bolts, the diagonal members then started to buckle at the first 1/50 of the compression cycle. Elbow buckling occurred at the second 1/50 of the compression cycle, and the member was torn off at the first 1/25 of the tension cycle. The maximum axial force to initiate buckling was approximately 820kN.

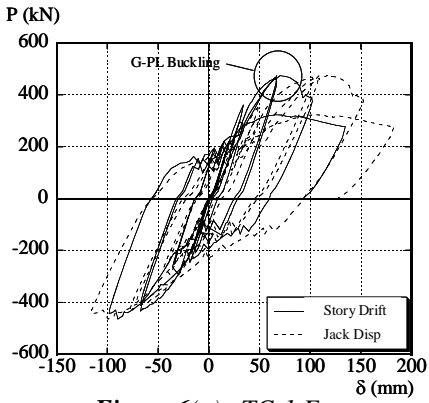
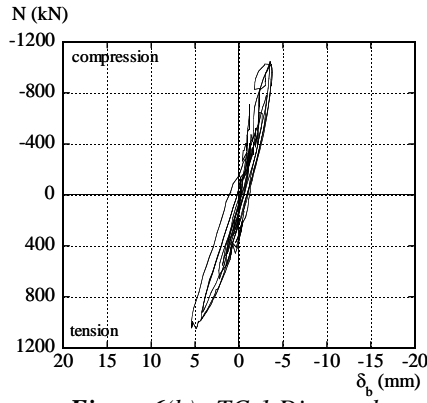
Figure 6(a). TC-1 Frame

Figure 6(b). TC-1 Diagonal

For TC-1, the beam side gusset plate started to deform along the out-of-plane direction at the first 1/50 of the compression cycle, and the gusset plate was completely buckled at the first 1/33 of the compression cycle before the brace buckled. The concrete in-filled member almost did not dissipate energy. On the basis of these results, it is found that the strengthening diagonal members might collapse the other parts as connections.

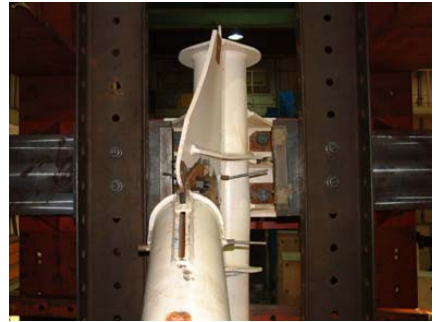
Figure 5(c). Gusset Pl. Buckling in TC-1

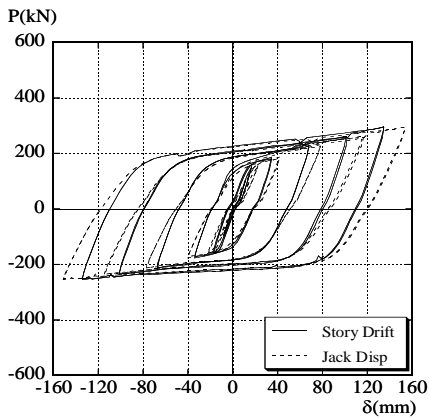
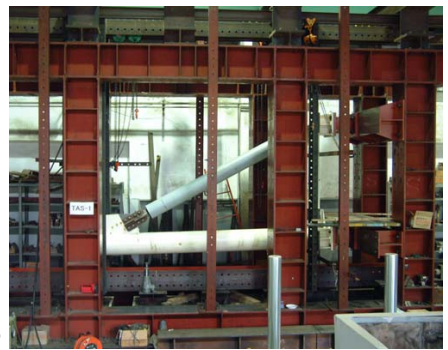
Figure 7(a). TA-1 Frame

Figure 7(b). TA-1 Diagonal

Figure 7(c). At the End of the Test (TA-1)

For the types with BRBs, braces and connections did not buckle, and they exhibited fairly stable and symmetrical hysteresis loops up to a story drift of

1/25. Each specimen dissipated sufficient energy until the core plate fractured (For TB-1, the core plate fractured at the third 1/25 of the tension cycle; for TA-1, the fourth 1/25 of the tension cycle; and for TA-2, the fourth 1/25 of the tension cycle).

For Type TA-1 and 2 with angle joints, the out-of-plane deformation did not increase and showed stable deformation capacity, similar to that of TB. The connection and main frame were not damaged until the BRB exhibited sufficient plastic deformation capacity and the connection damage was avoided as compared to TO-1 and TC-1.

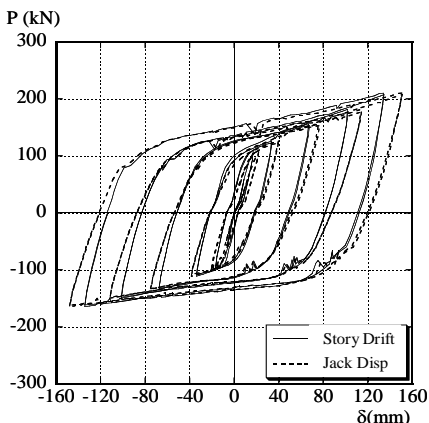
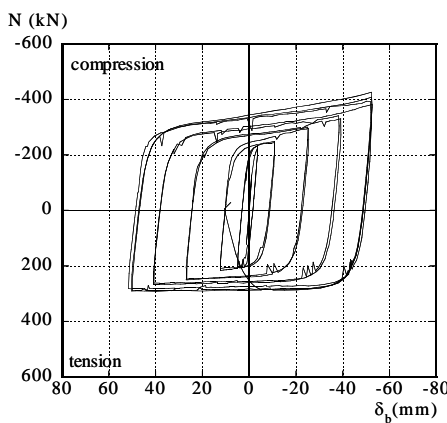
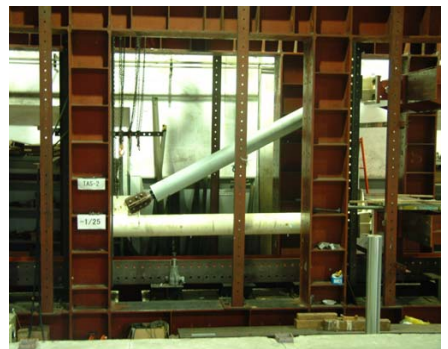
Figure 8(a). TA-2 Frame

Figure 8(b). TA-2 Diagonal

Figure 8(c). At the End of the Test (TA-2)

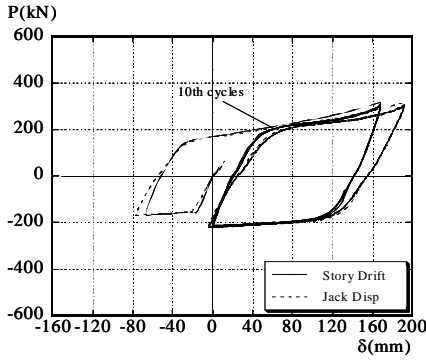
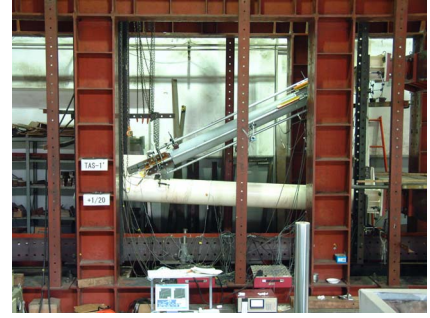
Figure 9(a). TA-1' Frame

Figure 9(b). TA-1' Diagonal

Figure 9(c). At the End of the Test(TA-1')

The test results for near-field loading programs are shown in Figure 9 and 10. In each figure, part (a) shows the load to vertical displacement relationships of the truss structure and part (b) shows the axial force to axial deformation relationships of the diagonal members. For TA-1' and TA-2', in spite of comparatively severe story drifts, no deformation and buckling occurred at the braces and connections. Both these types of connections exhibited stable hysteresis loops, at the 10th cycle in TA-1' and 16th cycles in TA-2'. As the maximum story displacement increases, the number of hysteresis loops increases until the core plate fractures; the cumulative deformation capacity depends on the amplitude rather than the maximum displacement.

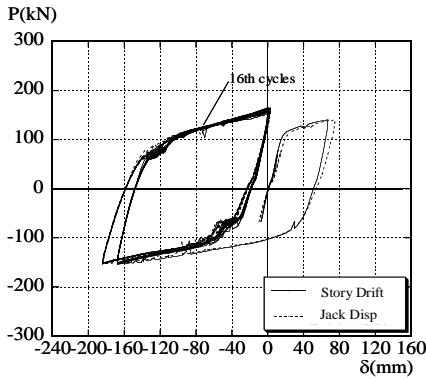
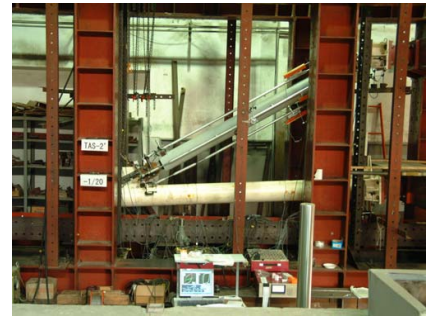
Figure 10(a). TA-2' Frame

Figure 10(b). TA-2' Diagonal

Figure 10(c). At the End of the Test(TA-2')

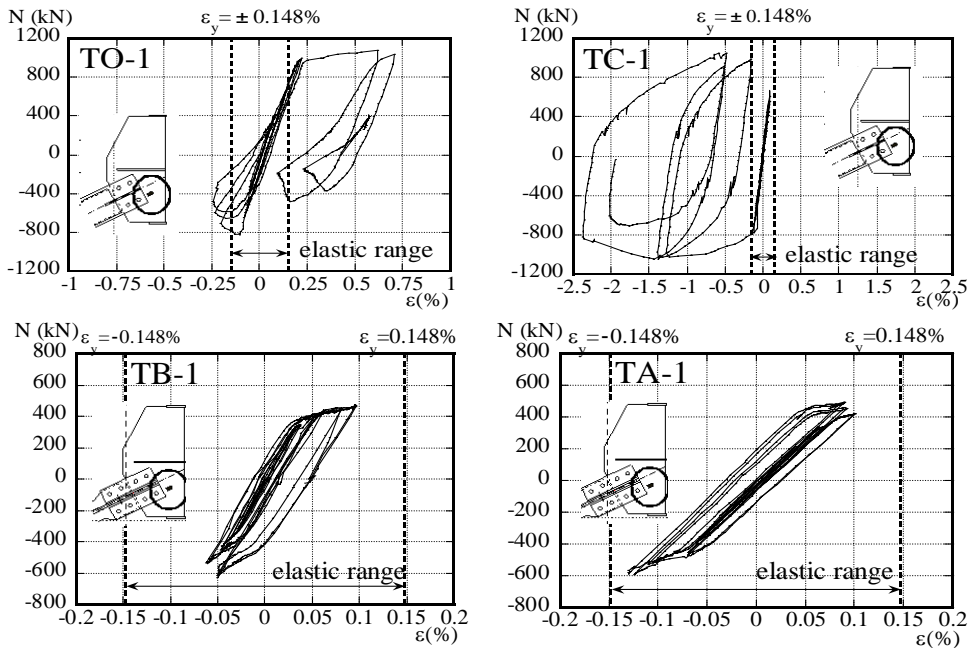
Figure 11. Strain Values of the Gusset Plates

Figure 11 shows the strain values of the gusset plates. After the brace buckles under compression, the gusset plate of TO-1 was considerably plasticized before the maximum strength of the braces under tension was attained. The gusset plate of TC-1 buckled along the out-of-plane direction and was

mostly plasticized before the brace buckles under compression. In Type TB-1, the strain value of the gusset plate is maintained within the elastic range because the maximum strength of the brace is limited. The strain value of the gusset plate of TA-1 is greater than that of TB-1 because it does not have welded ribs, however, it is still almost elastic. In TA-2, a similar result was obtained as that of TA-1.

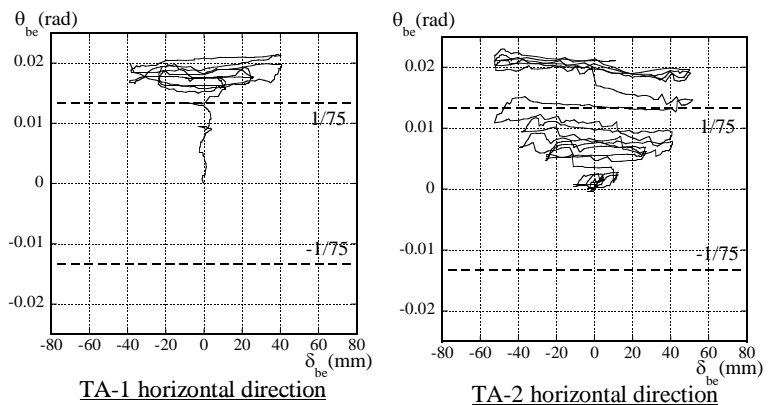
Figure 13. Axial Deformation and Rotation Angle at the End

Figure 12 shows the flexural behavior model of the BRB end, and Figure 13 shows the horizontal

rotation angle and axial displacement relationship. In these tests, the length of the BRB end is 300mm in order to avoid the formation of hinges. As shown in Figure 12, the BRB end deform crushing the unbonded material along the rotation. In the case that the restrained tubes do not deform, a rotational angle ($1/75$) is expected to occur along the thickness of the unbonded material. In these tests, it is found that all the test pieces rotate until a maximum amplitude of $1/50$. Some deformation in the restrained concrete seems to increase the rotation angle; however, the rotation angle along the out-of-plane directions is kept within $1/50$. Therefore, it can be concluded that these details have sufficient strength and stiffness to avoid buckling.

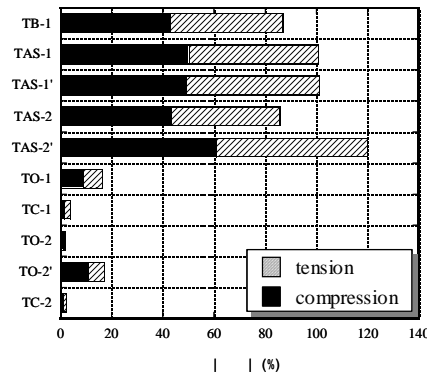
Figure 14. Cumulative Strain Capacity

Table 3 and Figure 14 show the cumulative strain capacity and Table 4 and Figure 15 show the dissipated energy until the occurrence of fracture. The cumulative equivalent strain capacities in a

diagonal BRB member are approximately 5 times greater than ordinary pipe members (TO-1). By estimating the performance before buckling, a BRB member has 10 times more capacity than TO-1. For the present ordinary pipe, the dissipated energy capacity is limited and the buckling possibility of the brace or connection buckling is high. By replacing the brace with BRB member, the yield strength gets limited, and damage to the other members or connections is avoided. With the near-field loading histories of TA-1' and TA-2', similar displacement capacities can be observed as the basic loading histories. Here, the damper members exhibit stable capacities in all the types of loadings.

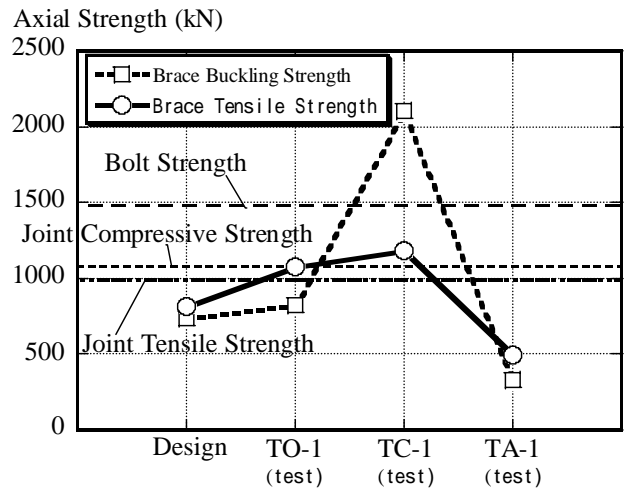
Figure 16. Strength Comparisons

Figure 16 shows a comparison of the strengths of braces and joints. At the time of designing, estimated brace strength is considerably smaller than the joint

strength, however, the actual brace strength is almost equal or higher than the joint strength. Figure 17 shows the distribution map of the yield strength of steel materials. The yield strength of the pipe materials (STK400 and 490) shows considerably higher values than the design yield stress (F-value) and the distributions of ordinary steel materials (SS400 and SM490). Therefore, it is necessary to confirm that the brace strength is not higher than the joint strength.
